Project plan for Vallkärrabäcken

Potential actions to improve recreational values and nutrient retention

Group 5 - BIOR66

30 May 2018

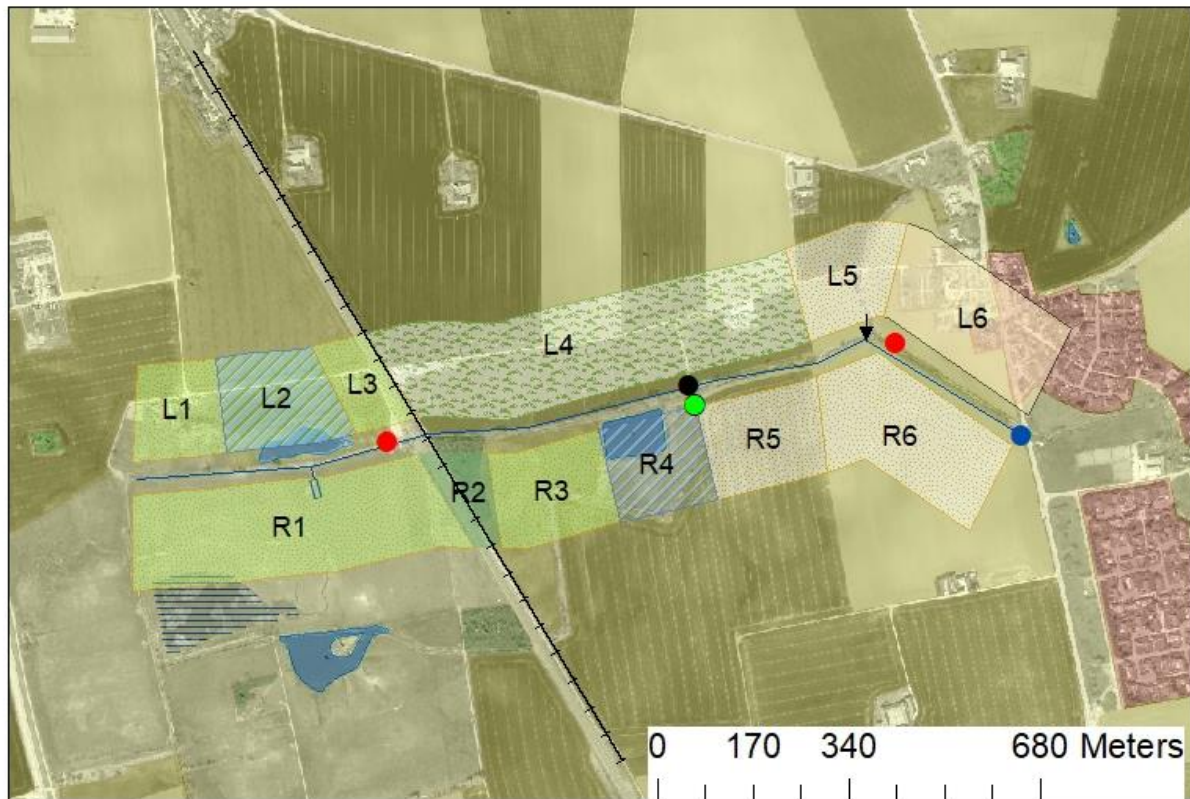
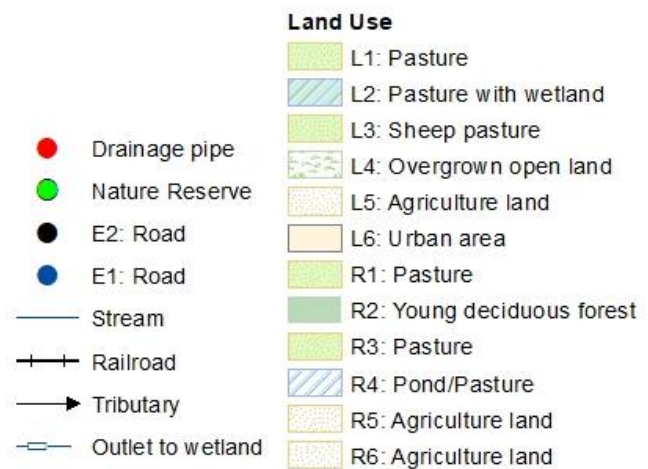
Fig. 3.1 Habitat mapping of the investigated part of Vallkärrabäcken.

The results from Protocol B, that describes ambient habitats and the close surrounding of the watercourse are presented in a map, Figure 3.1. The close surroundings consist mostly of open land and agricultural land and the stream is located near the urban area Vallkärra, section 6 in Figure 3.1. Passages from protocol E is mapped in Figure 3.1, where point E1 on the map indicates the location of a busy paved road and point E2 indicates a small gravel road. At point E2 is also where the nature reserve begins (green circle). Noticeable restoration of the stream was seen in the part that was located in section R2-R4, where recreational improvements were made as well, with informative signs about biodiversity. The previous restoration performed is described in the introduction.

The surrounding is as described in the introduction the main cause for the eutrophicated waterstream, and during the field investigation the overload of nutrients was clearly presented as the stream consisted of and was surrounded by high amounts of vegetation, see Figure 3.4. The stream itself was not visible during most sections due to the vegetation, invasive cow parsnip and steep edges around the stream, which hindered the team from approaching the waterstream at some sections and executing a thorough examination of the drainage pipes. The amount of drainage pipes that was observed might thus be far from the accurate number. Although, it was manageable to conduct width, depth and flow measurements of the stream as well as an sedimentation observation at three locations, presented in Table 3.1.

The river flow and the shape of the river that was observed was almost consistent in all sections, hence only three observation section were needed. As one can see in Figure 3.1 the stream is straight through the whole studied stream section and yet Table 3.1 indicates a low water velocity and a low water depth. The reason for this might be that low amount of water was running in the stream during the field study, and that during precipitation the straight stream causes high velocity.

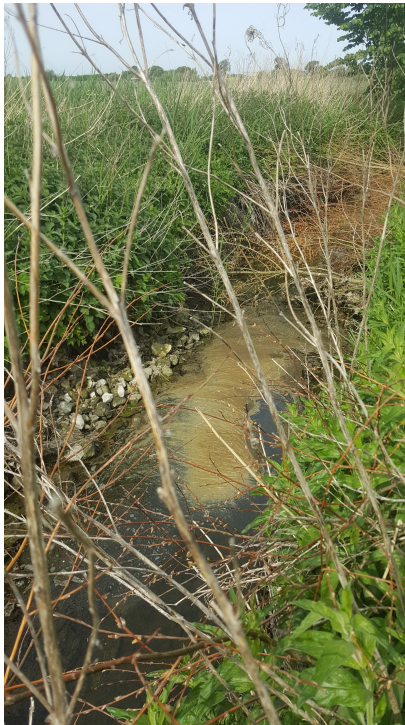
Fig. 3.2 The stream in section L6/R6.

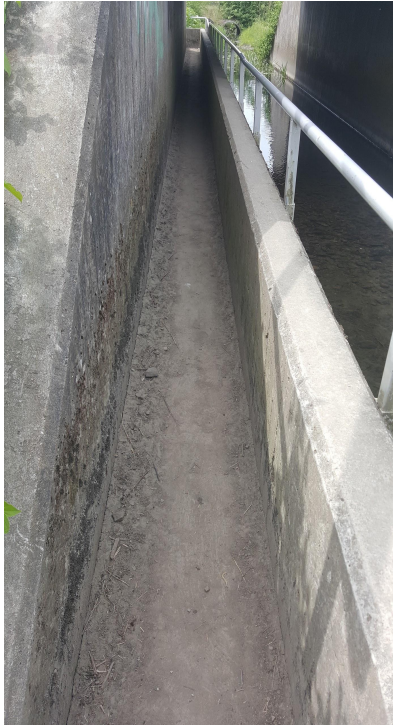
Fig. 3.3. The railway underpass located in section R2.

As the walking path reaches the railway it is possible to use an underpass, see Figure 3.3. Since the underpass is placed just above the stream it is a risk that the walkway will be flooded during

wet periods and it is therefore suggested to do some changes at this point. It is important to solve the underpass issue, otherwise there is a risk that visitors will cross the railway trails. The alternatives are to adjust the height of the underpass to avoid flooding (e.g. raise the walking platform), make some kind of drainage system to lead away water from the walking path or adjust the depth and/or the width of the stream before the railway.

By reason of the problem of varying flows within the stream due to changes in stormwater runoff during the seasons, the best alternative would probably be to decrease the water flow upstream the railway during wet periods. This can be done by constructing a wetland or most preferably several wetlands which can lead away water from the stream if necessary. Creating wetlands, besides reducing the risk of floods, increase biodiversity, improve recreational values and nutrient retention. If constructed wetlands upstream the railway is not enough in order to avoid floods, combining solutions might be the key. Furthermore, the underpass is gray and dark so it is proposed to add some kind of paintings to the walls such as colorful graffiti to make the underpass nicer to pass. Perhaps this can be achieved by using a local painter or take help from a nearby school.

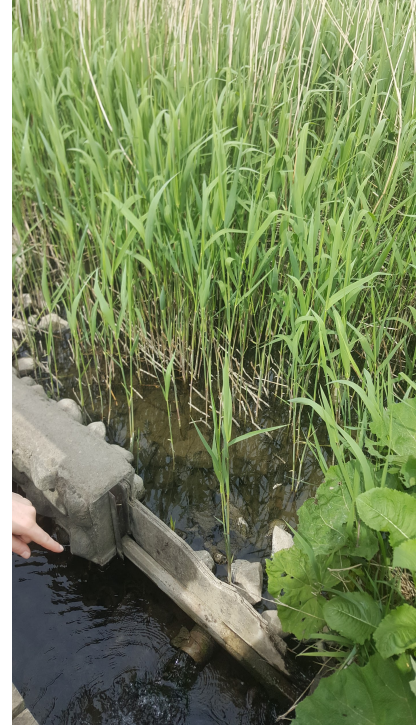
Fig. 3.4 Drainage pipe to a wetland, marked in the habitat map.

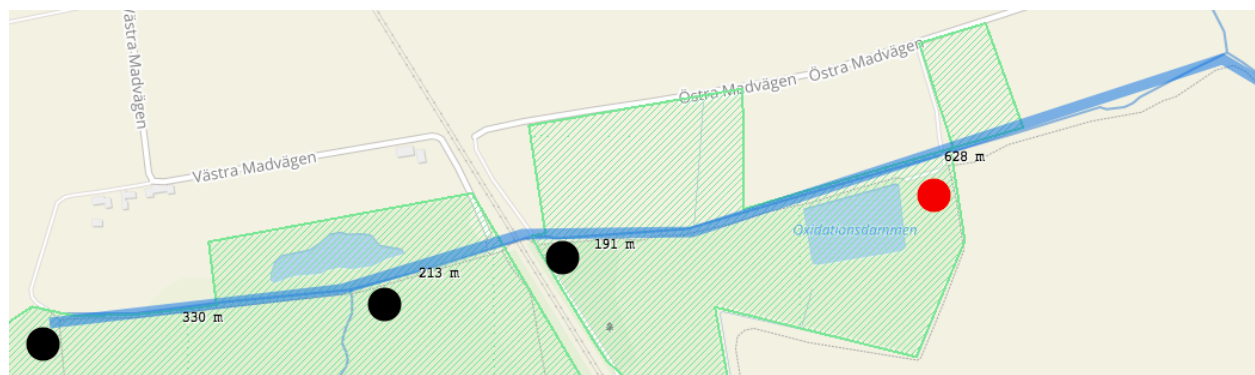
Fig. 4.2. The suggested positions for benches (black dots) and for a toilet (red dot) along Vallkärrabäcken (blue line). The nature reserve in the area is also marked in the map (green cross hatched area). The dots is added to the map by the authors (VattenAtlas, 2018).

Additionally, a lack of benches was noted during the field study and also mentioned from one interview, Table 3.2. Therefore, it is suggested to place some more benches in the area, preferable with a nice view of the stream and/or the wetlands. To further improve the area for visitors one should also place at least one toilet along the walking path. The map in Figure 4.2 shows suggested locations for a toilet and for benches. The recommended position for the toilet is a place where it is already today possible to sit close to the water and there is a nice barbecue site with view towards the cow pen. The site is also close to a road which is beneficial from a maintenance perspective. If considered possible to insert toilets in the area, trash baskets should also be placed at the same locations since the maintenance of trash baskets can be made at the same time as for the toilets.

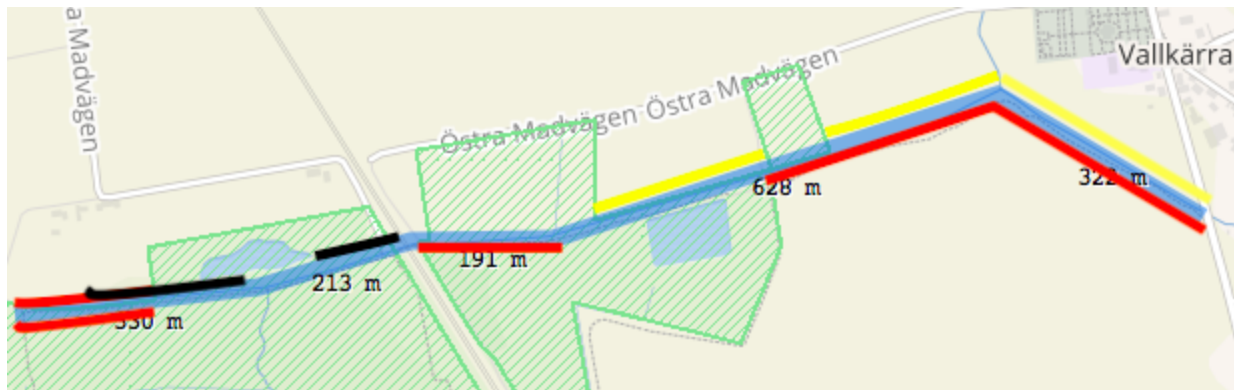
Fig. 4.6. Is an example where actions for reducing erosion, increasing buffer zone and plant trees. The red line indicate where two-stage channel or just trimming the slopes if most needed. The yellow line is action for buffer zone. The black line is where tree planting is needed. The lines is added to the map by the authors (VattenAtlas, 2018).

In order to reduce the high concentrations of nitrogen and phosphorus in Vallkärrabäcken it is recommended to increase the width of the buffer zones, especially in section L5 and L6. These sections consist of agriculture land and by inserting larger buffer zones between the agriculture land and the stream (preferably at least ten meters), the leakage of nutrients into the stream can be reduced. Of course dialog and discussion with the farmers in the area are necessary since their farming land will be reduced if inserting larger buffer zones. The buffer zones can also create different habitats to increase the biodiversity. Vegetation in the buffer zones can increase the uptake of nutrients and contribute shadow to the stream. It is recommended to place more trees in especially the sections L1-L3 due to the lack of shadow in these sections.
